MultiPlus-II/EasySolar-II/Quattro-II Current Sense socket issue

Tech note – December 2021 - rev 4

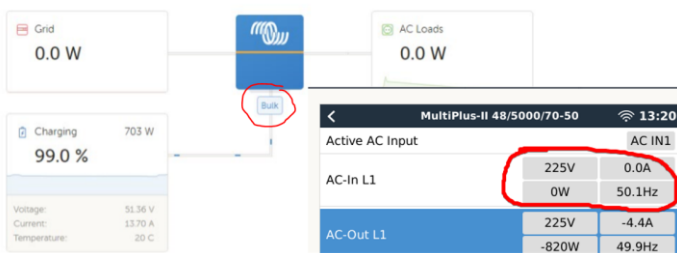
And lastly, in all above mentioned cases the real power from/to the grid will have no relation with the power displayed on the GX, VRM Portal, VictronConnect App or VEConfigure.

Picture left showing incorrect data on (CC)GX and the VRM Dashboard.

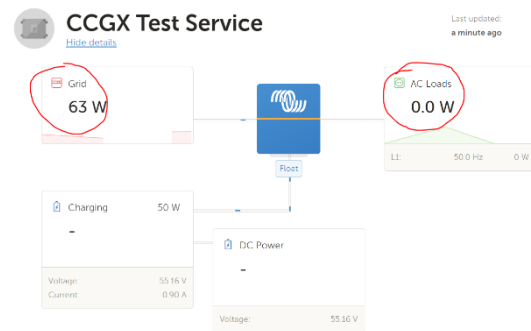
Picture right showing 0.0W AC Loads and 63W consumed power from the grid. In reality a 600W load is connected.

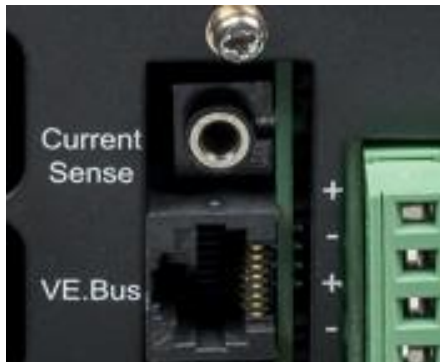
3.5mm audio jack (OLD - affected)

All MultiPlus-II, EasySolar-II and Quattro-II models, featuring the audio jack type socket as shown on picture on upper right of this document, can be affected. The problem does not occur often, but is hard to recognise in case you are not aware of the possibility – while simple to solve.

The background: in the socket, there is a mechanism that electrically connects the internal current sensor to the measurement circuitry. Inserting an external current sensor breaks that connection and makes it use the external current sensor instead. The problem is a bad contact when there is no external current sensor inserted.

To fix the contact, first switch the unit off and then briefly insert a 3.5mm jack plug (standard old style headphone plug) in the connector. Remove and re-insert the jack plug a few times to clear the issue. Finally, remove the jack plug and switch the unit back on. The problem is now resolved.

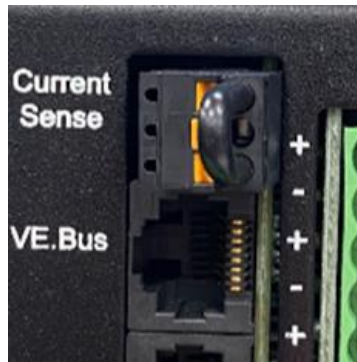
3-pin connector (NEW – not affected)

On newer models, the audio-jack socket used as a connector has in newer models been replaced by a 3-way standard connector with a wire bridge.

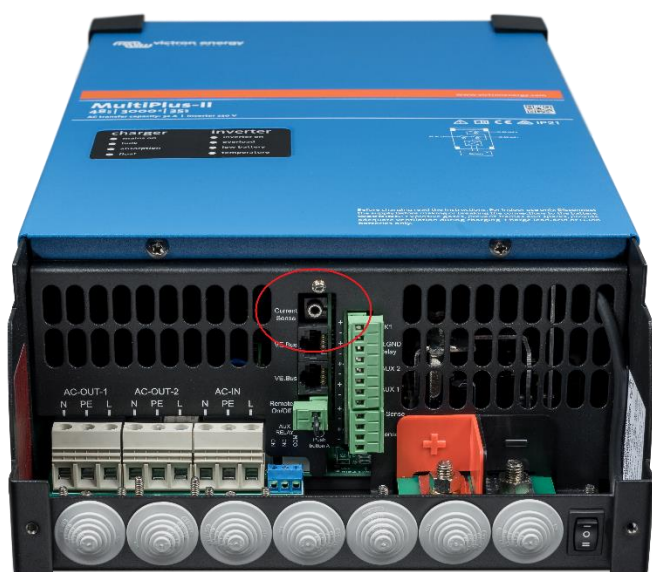
Picture of the connections of the MultiPlus-II. Encircled the Current Sense socket.

Step 1: turn the I-0-II switch, see lower right in below picture, to the '0' (Off) position.

Step 2: open the black connection cover by unscrewing the two screws at the bottom.

Step 3: insert a 3,5mm jack plug (any 3.5mm jack plug will do, also when connected to a headphone), and remove it. Do this a few times. Then remove the plug.

Step 4: Turn the unit 'On' and check on your GX device and/or on the VRM dashboard to see if the AC-input current is showing the correct values.
